Re Final Report on Birch Spring Investigation, CO-OP Mining Co., Bear Canyon Mine,
ACT/015/025, Outgoing File

RE: Birch Spring Findings for Technical Directive 005, Co-Op Mining Corporation, Bear Canyon Mine ACT/015/025, and Star Point Mine, ACT/007/006, Internal File

The Issue: The Reason for Decreased Flow at Birch Spring is Undetermined.

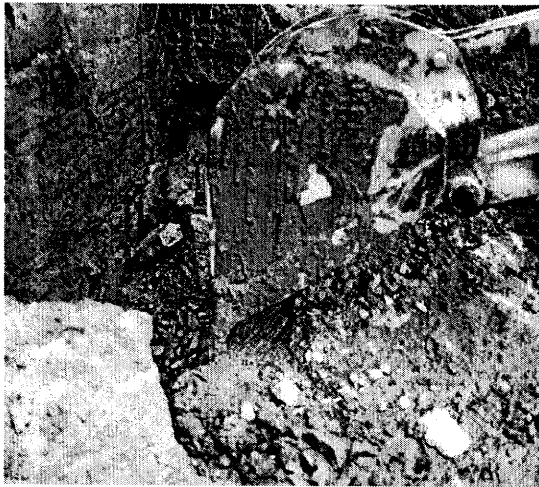
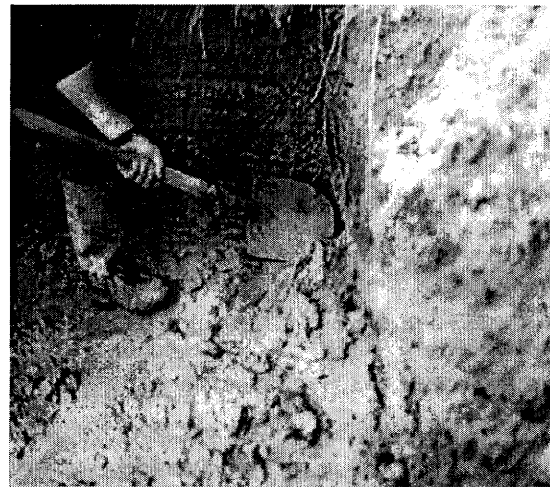
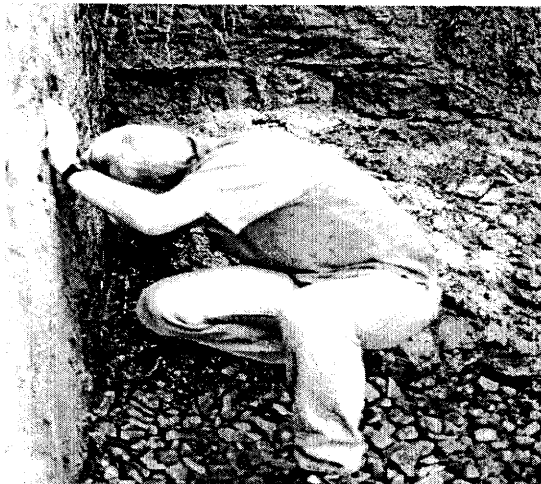
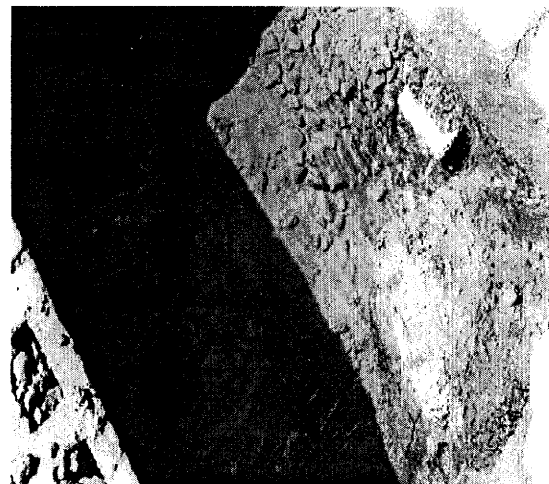
Birch Spring Investigation: Spring Source #1

In September 1998 NEWUA opened spring boxes #1 and #2. Mr. Peter Hess from the Division of Oil, Gas and Mining accompanied Jack Stoyhoff from the NEWUA. Mr. Hess noted that at box #1 the collection box was full of gravel and sediment and water ran over the top of the collection box. It was estimated that approximately 15 gpm flowed from source #1 after cleaning the box. Mr. Hess took photos of these sites on September 21 and 24, 1998. These photos are in Appendix B.

Spring Source #1, as shown on Map 1, is located on the west side of the alcove and is the down gradient source (Figures 1-4). Water was running over the collection box in (Figure 2) prior to opening the box. Silt and sediments were noted in the fracture and collection box when it was unearthed (Figures 3 and 4). Charles Reynolds is removing silt from the fracture in Figure 3.

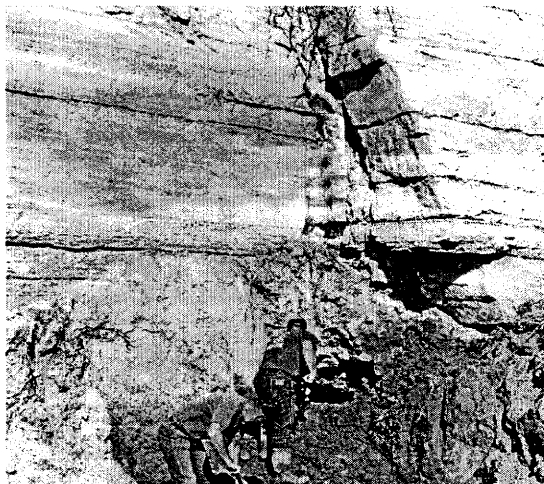
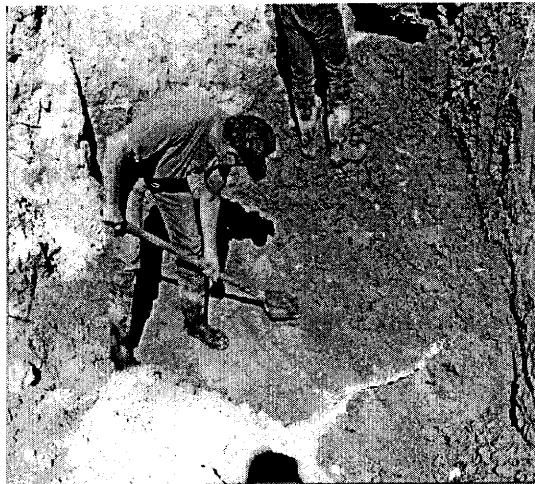
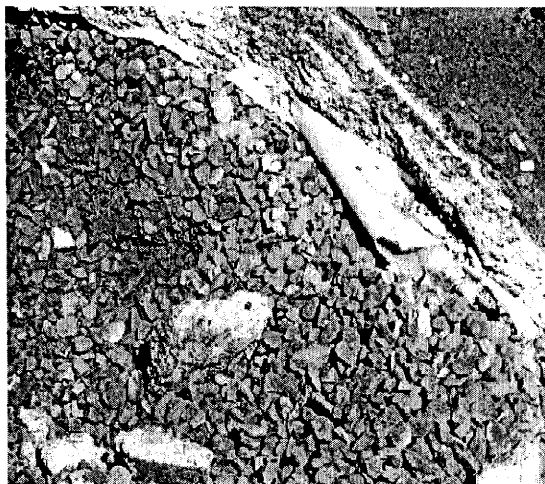
Birch Spring Investigation: Spring Source #2

Spring Source #2 is located on the west side of the alcove and is the up gradient source #2 as shown in Map 1. Silt and sediments were noted in the gravel filter.
